# ***To Laycock or not to Laycock??***

Trials & Tribulations of TR6 Clutches

Brent Kiser

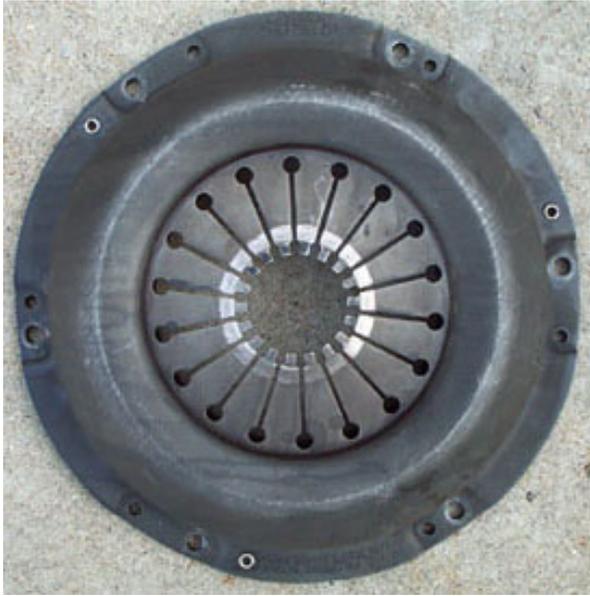
Original Laycock Cover Side

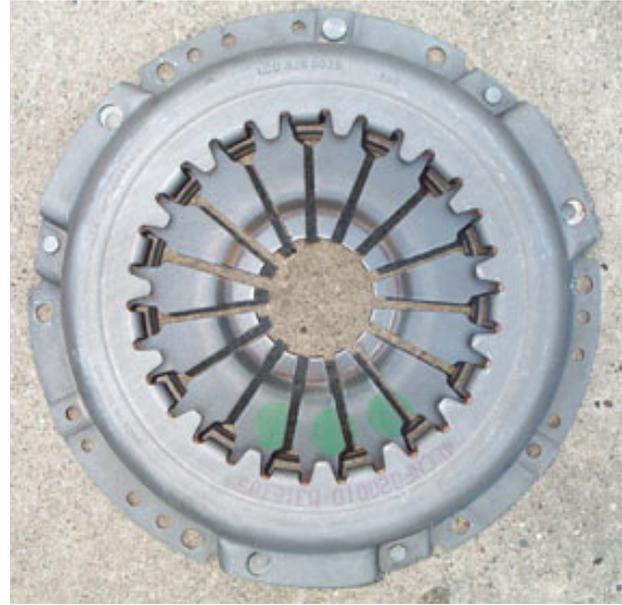
Aftermarket Borg & Beck Cover Side

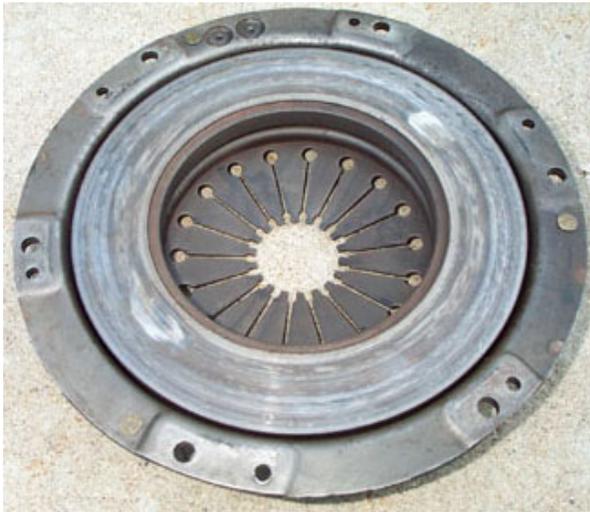
Original Laycock Plate Side

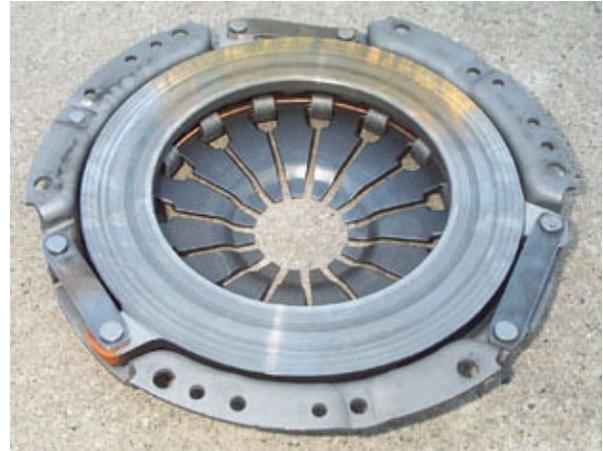
Aftermarket Borg & Beck Plate Side

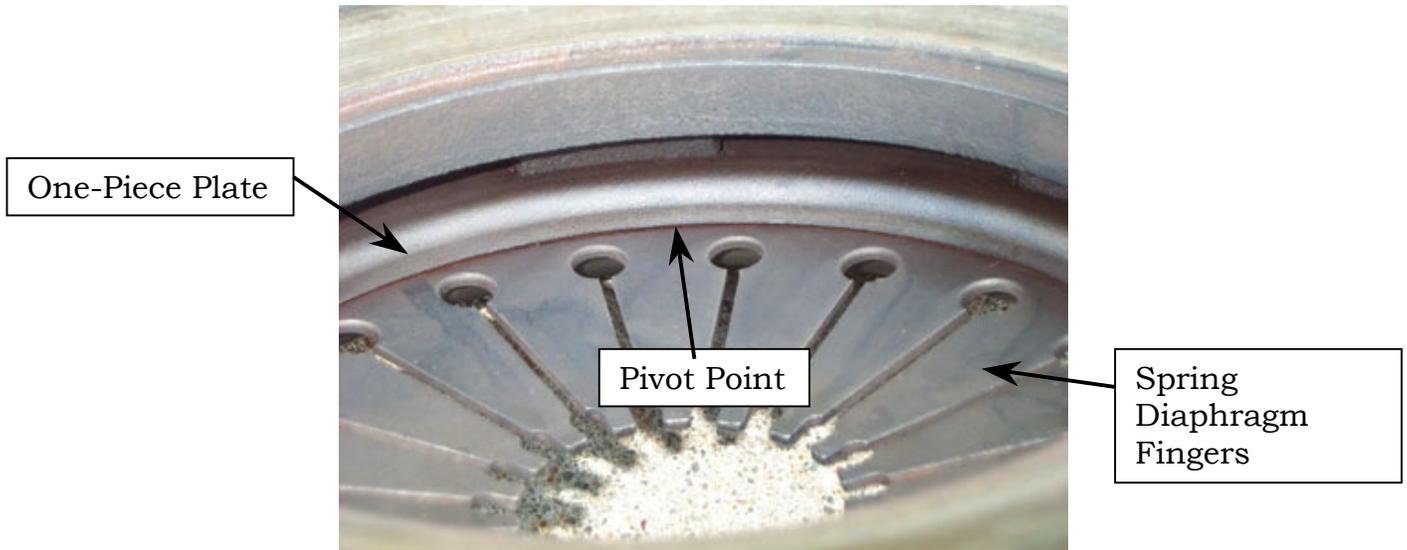
Original Laycock Pressure Plate

The original Laycock has a solid, one-piece plate for all of the fingers of the spring diaphragm to pivot about when the clutch was released. Plus, the pivot point was outside of the point where the fingers of the spring diaphragm joined. This design creates a solid, single plain for all of the spring diaphragm fingers to rotate about.

My recommendations to any TR-6 owner who has an original clutch assembly and is considering replacing their clutch is to replace only the release bearing and clutch disk. Keep the original Laycock pressure plate.

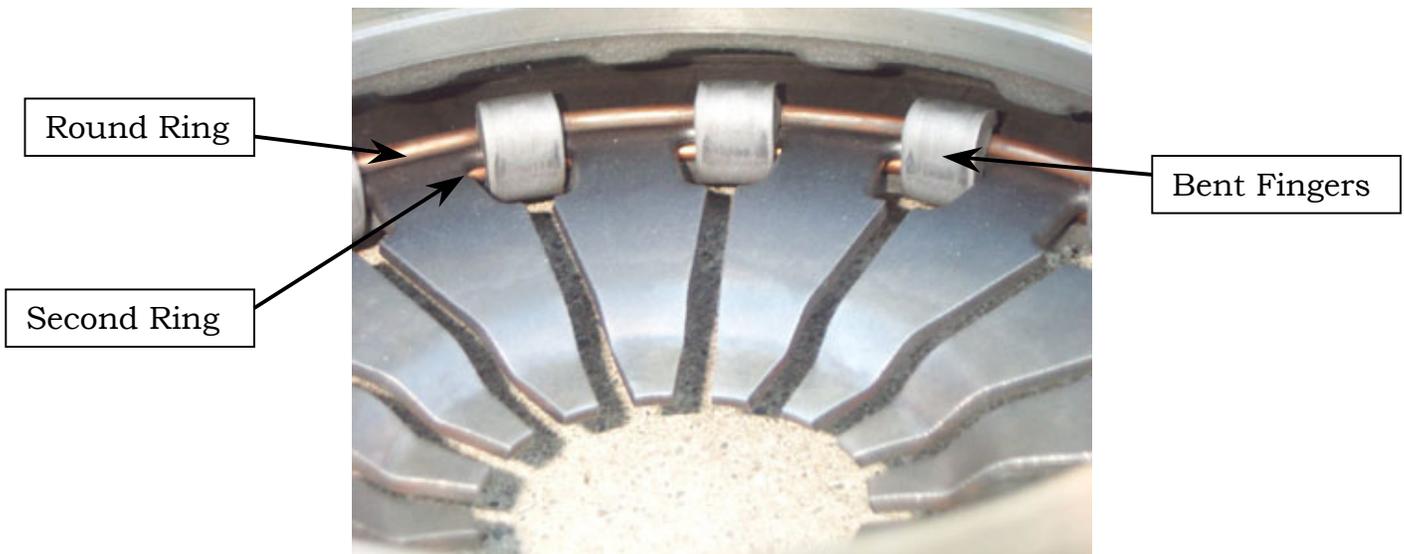
Aftermarket Borg & Beck

The aftermarket Borg & Beck has two round rings held in place by several bent fingers on the cover plate as the fulcrum point for the diaphragm spring fingers. Plus, the fingers joined outside of the round ring.

Bottom line: The aftermarket Borg & Beck design would be almost impossible to mass produce with the exacting tolerances required to assure all of the fingers pivoted about

the same plain. Having multiple pivot points at different plains would cause the binding and sticking seen on engagement of the pressure plate.

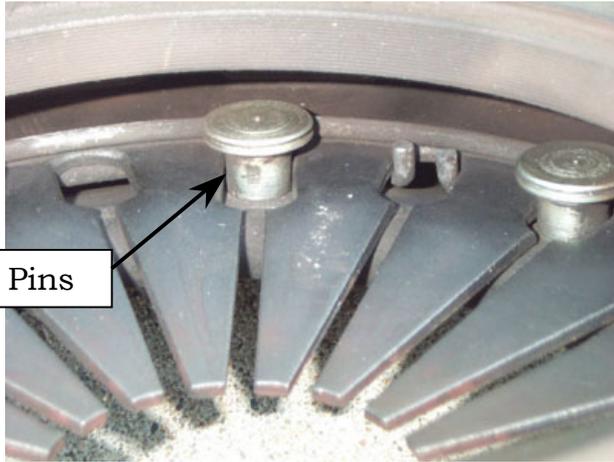
Original Borg & Beck

As you can see in the pictures, there is a great difference between the original and aftermarket units. It is no wonder that people have been telling me their original Borg & Beck work great and I have claimed the Borg & Beck does not work. We were talking about two different designs!!

Since discovering this difference, I have installed over six rebuilt original Borg & Beck pressure plates and have not had any problems. I strongly recommend the rebuilt original Borg & Beck pressure plate.

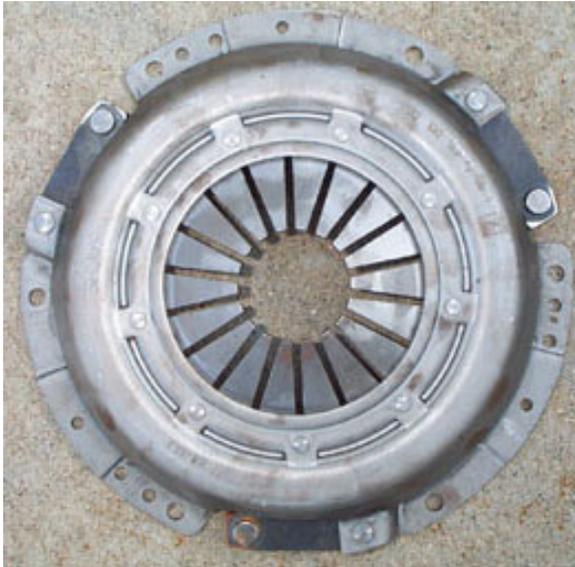
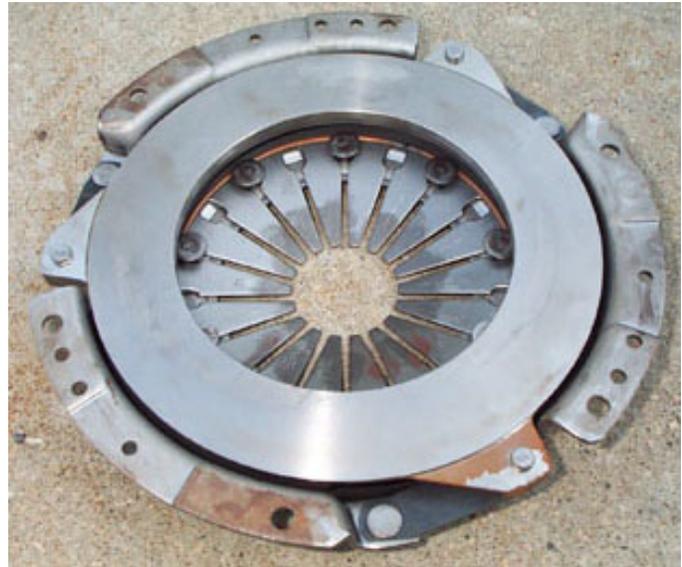
“The Magic Clutch”

When you look at the Sachs pressure plate you will see it is like the original Borg & Beck design with the pin type pivot point.

Sachs Cover Side

Sachs Plate Side

The design of the Sachs is the better than the aftermarket Borg & Beck it still has too strong of spring. I cannot recommend the Sachs unit.

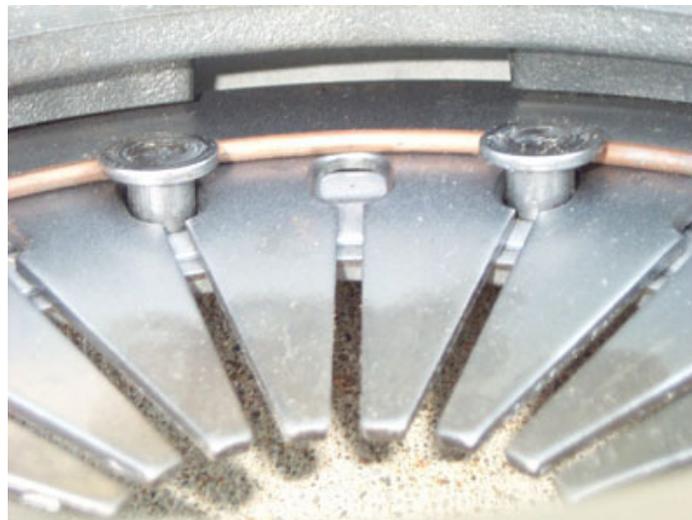
Sachs “Pin Type” Pivot
