TECHNICAL SERVICE BULLETIN

76-A-11

AUTOMATIC CHOKE ASSEMBLY

TR7
CALIFORNIA SPEC. ONLY

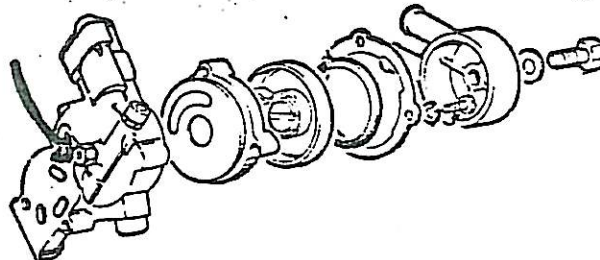
Instances have been reported where the automatic choke assembly works loose in service, rendering the carburetter inoperative or in some cases, allowing it to operate at full rich position.

The inner choke mechanism is secured by a brass nut located at the back of the choke assembly (refer to diagram). It is suggested that this nut be checked for proper security during PDI, and at the same time make sure that all mounting screws are tightened thoroughly.
