# ***To Laycock or not to Laycock??***

Trials & Tribulations of TR6 Clutches

Brent Kiser

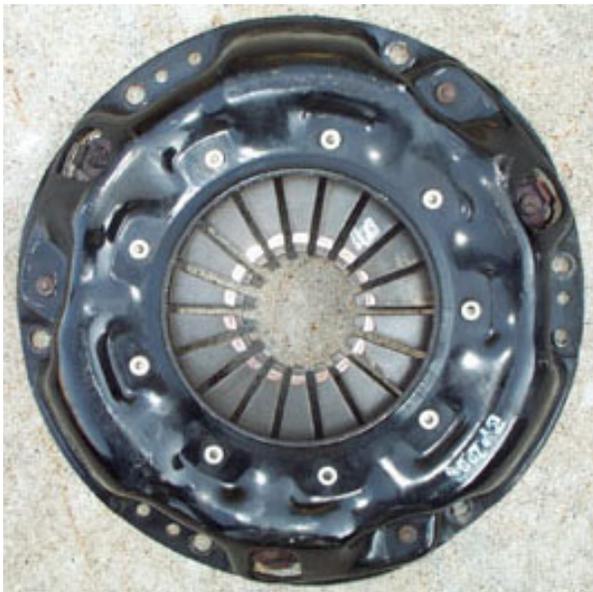
Original Borg & Beck Cover Side

It became obvious at first glance that the original and aftermarket Borg & Beck pressure plates are not even close to the same design. The original Borg & Beck is what I call a “Pin Design” pivot point versus a “Bent Finger” pivot point.

Since discovering this difference, I have installed over six rebuilt original Borg & Beck pressure plates and have not had any problems. I strongly recommend the rebuilt original Borg & Beck pressure plate.
